#### Figure 6: Area 5 Post-excavations Gamma Scan

NIAGARA FALLS BLVD  
NIAGARA FALLS, NEW YORK

U.S. ENVIRONMENTAL PROTECTION AGENCY  
REMOVAL SUPPORT TEAM 3  
CONTRACT # EP-S2-14-01

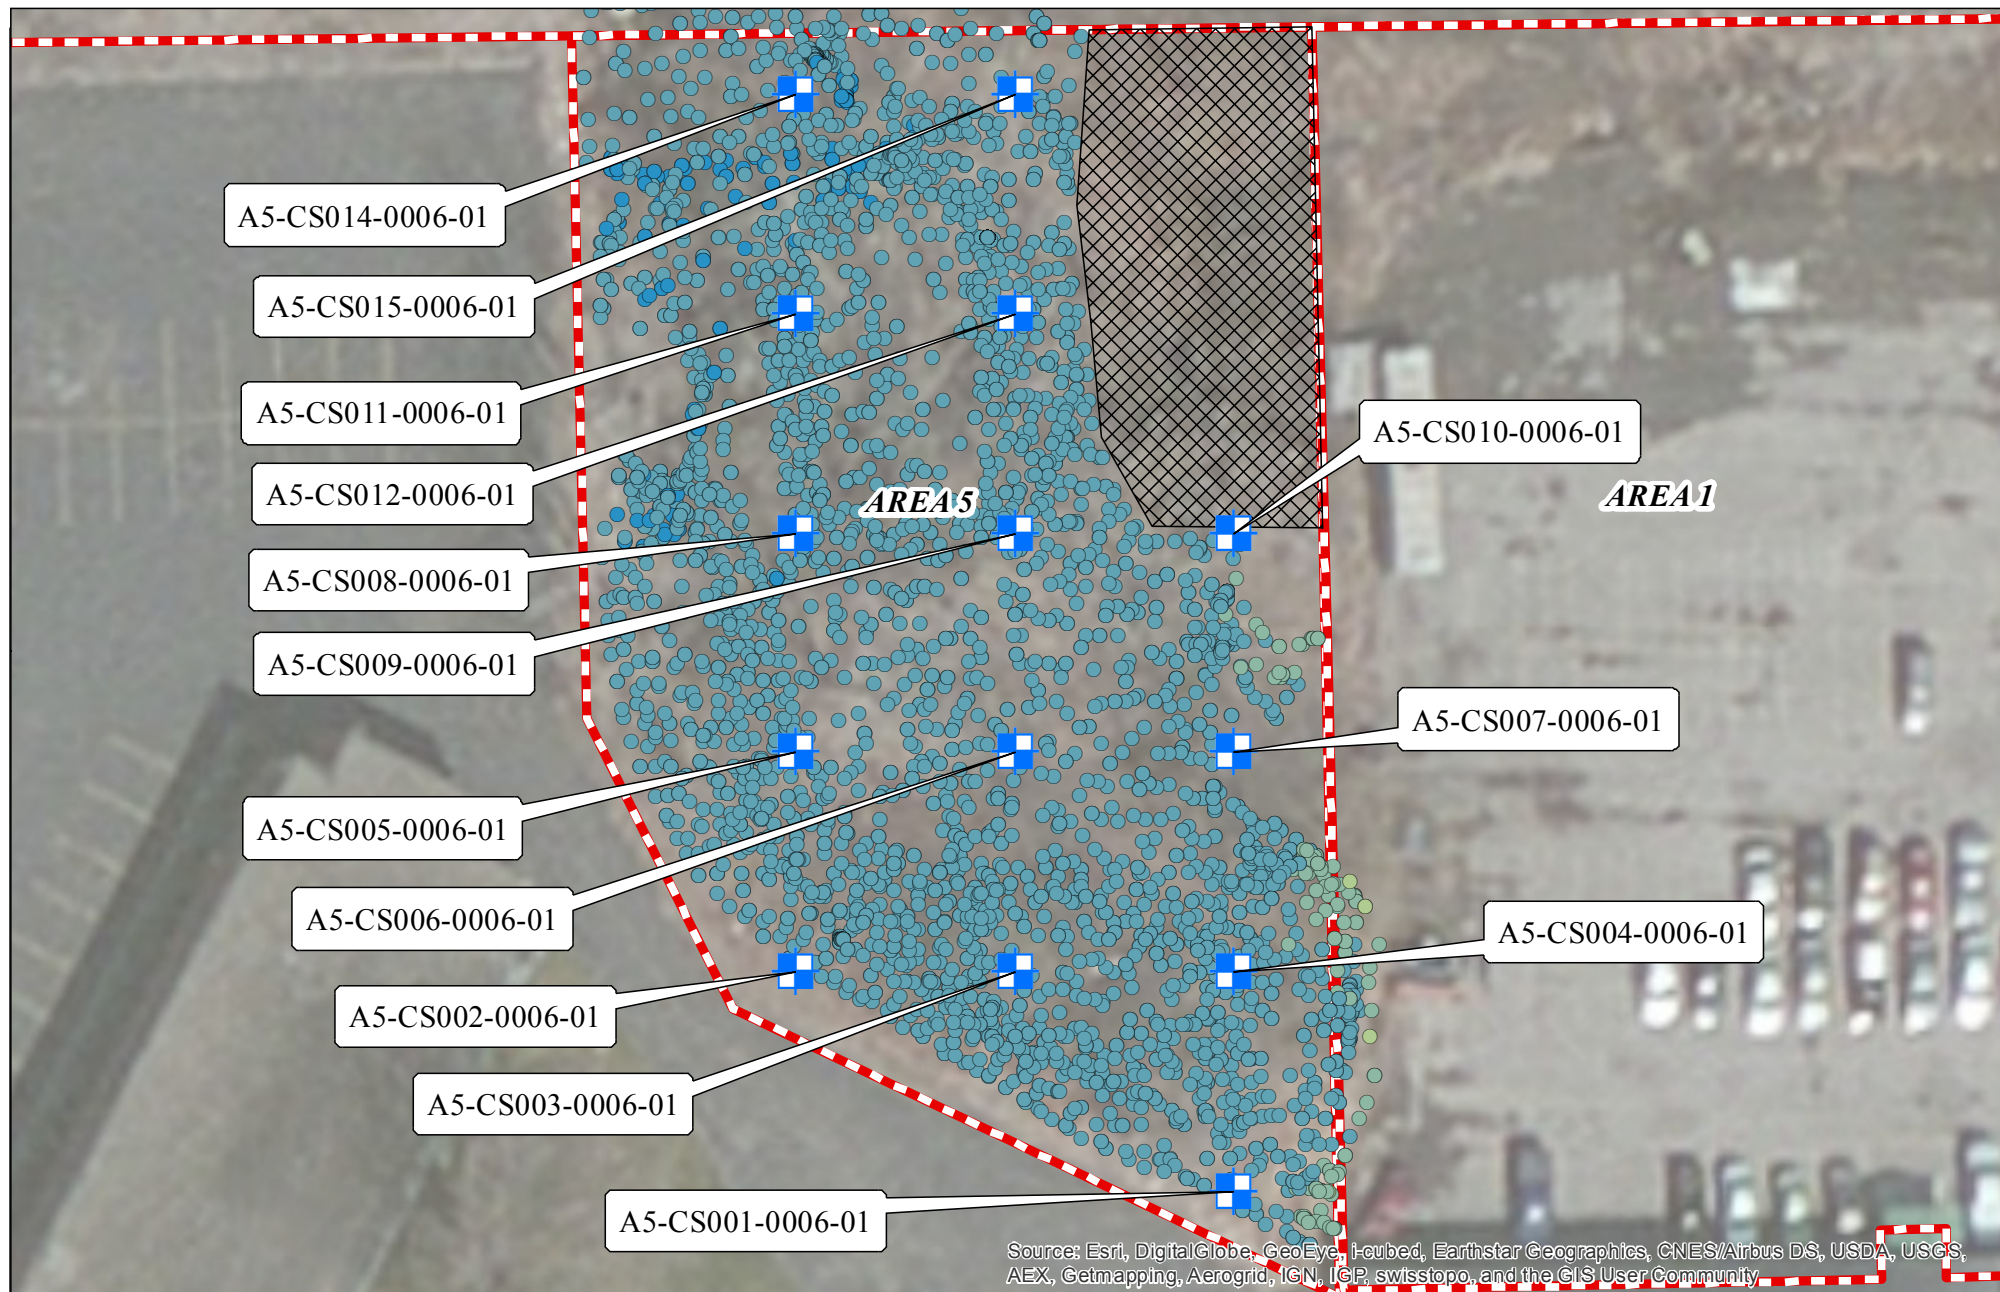
Gamma survey conducted with Ludlum 3x3 Sodium Iodide Detector.  
Gamma survey measurements presented in micro-Roentgen per hour (µR/hr).  
Background reading: 15 µR/hr.  
Area 5 maximum gamma reading: 51 µR/hr.
